2D-Modelling of Earthquake-Induced Rockfall from Basaltic Ignimbrite Cliffs at Redcliffs, Christchurch, New Zealand

A thesis submitted in partial fulfilment of the requirements for the degree of
Master of Science in Engineering Geology
at the
University of Canterbury
by

Abstract

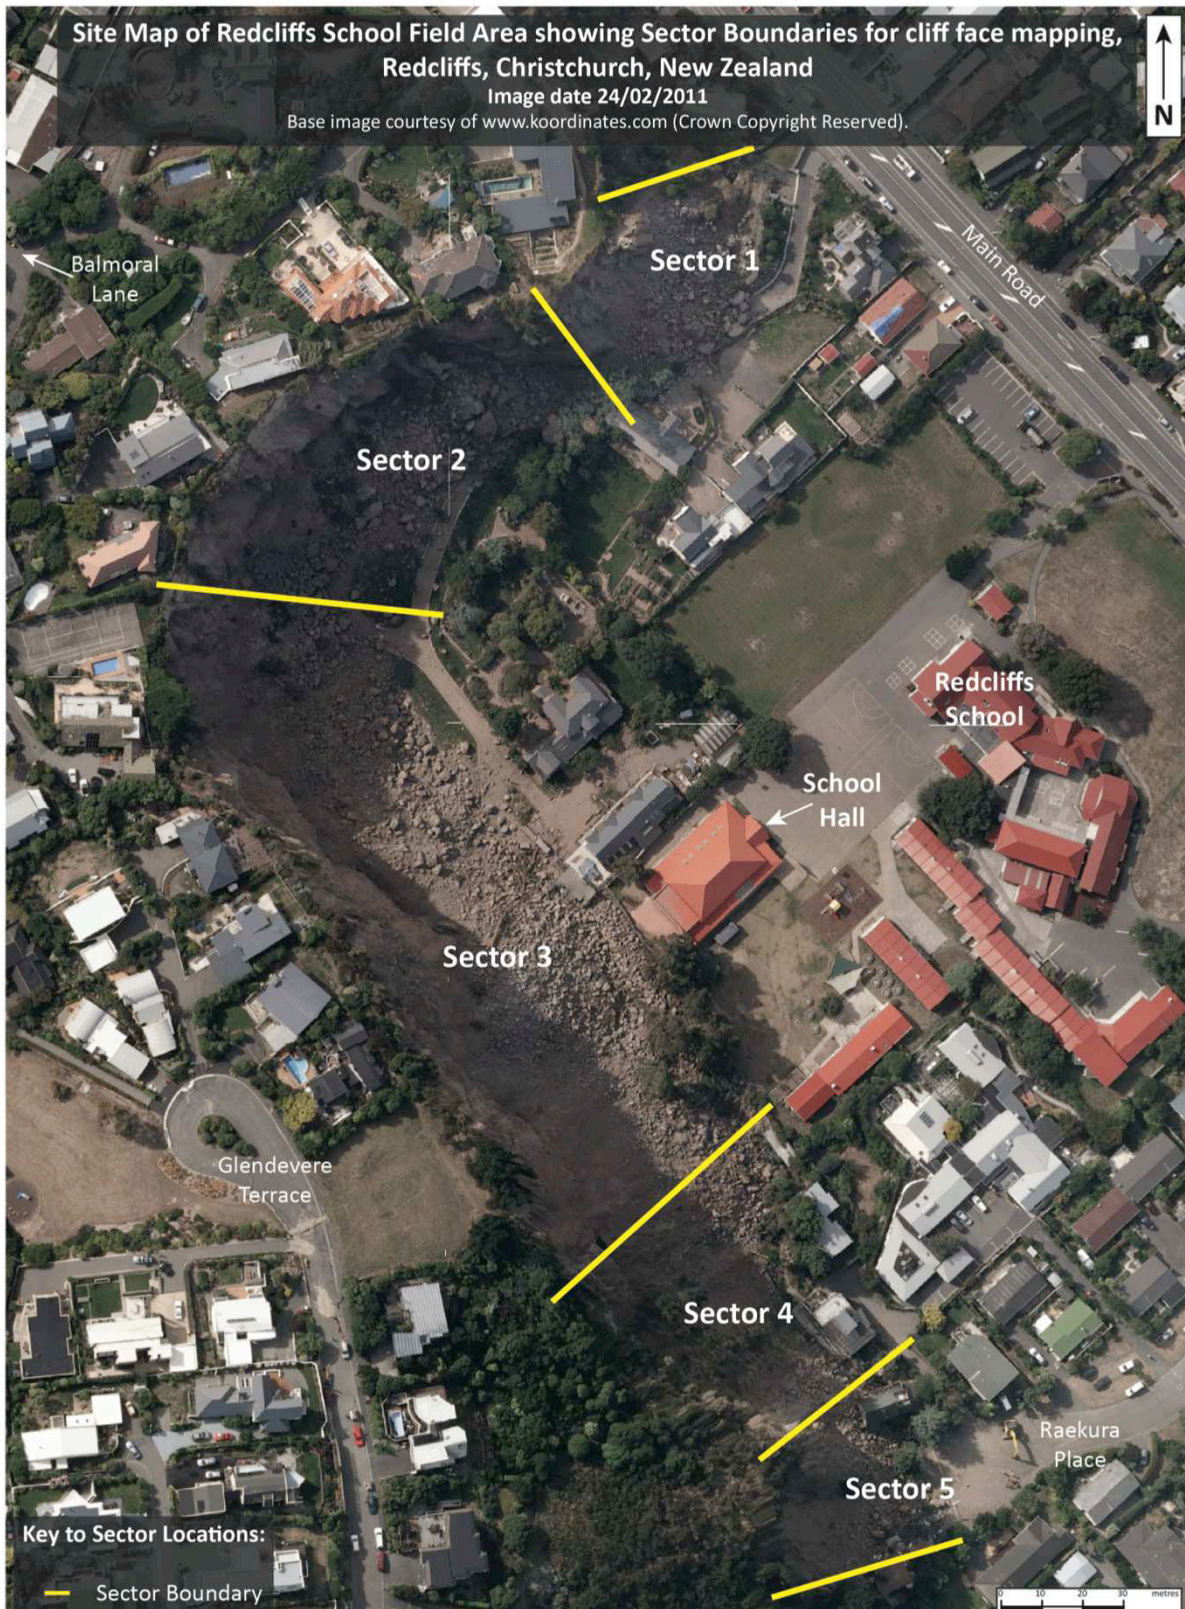
Figure 1.3: Location of the field area at Redcliffs, divided into five sectors. Areas beyond Sector 1 to the north, and Sector 5 to the south, and all land beyond the top of the cliff, is not included in this study.

The cliffs at Redcliffs are a dominant feature of the landscape, standing over 70m high in places, and extending approximately 900m from Moa Bone Point to Raekura Place, Redcliffs (Figure 1.3). The cliffs are composed of material erupted from Lyttelton Volcano during the latter stages of the eruption phase, and were modified by marine action when sea level reached its present elevation at about 6,500 year BP (= before present) following Postglacial sea-level rise (Brown & Weeber 1992). According to recent work (Hampton 2010; Hampton & Cole 2009), Lyttelton Volcano was a complex containing 15 eruptive centres rather than two large ones (Shelley 1987, in Forsyth et al. 2008). A summary of Banks Peninsula geology was presented in Chapter 1.

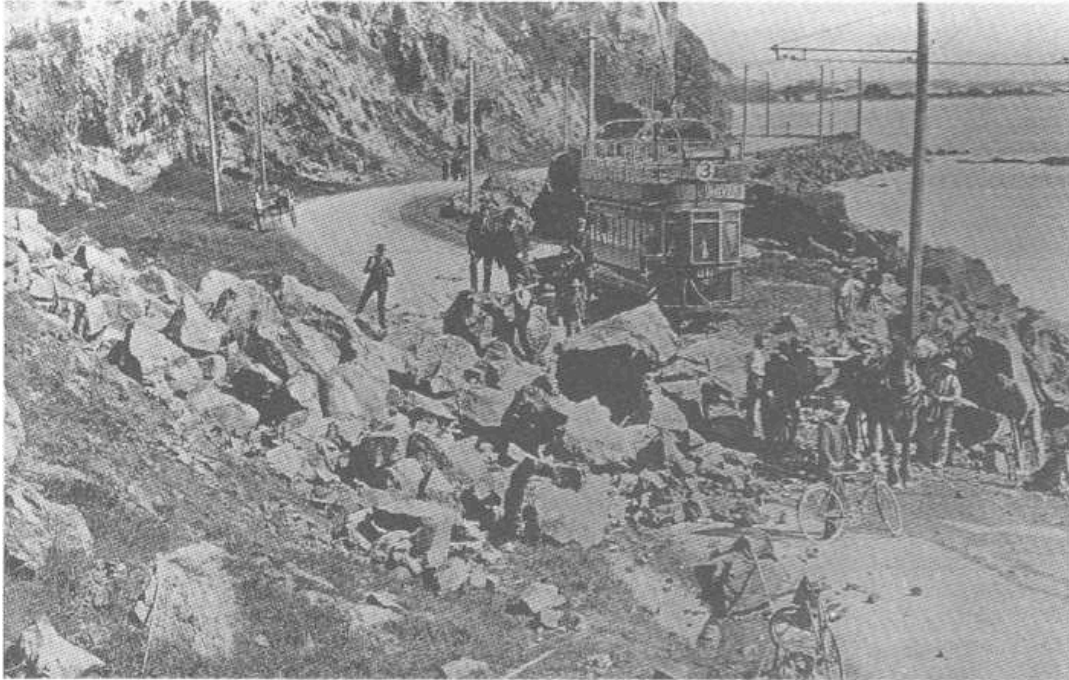
Figure 2.1: Rockfall blocking road and tramline, Clifton, Sumner on 9th October 1912 (Photo: *Canterbury Times*, *Canterbury Museum collection*; Brown and Weeber 1992).

Prior to 2011, rockfall occurrences in the Port Hills have been generally infrequent and minor in terms of fallen volumes and effect on people and infrastructure. Figure 2.1 shows a photograph of a historic rockfall at Clifton, Sumner that blocked both the road and the tram line on 9 October 1912 (Brown & Weeber 1992). Those authors reported significant historical rockfalls to have occurred in 1968, 1970, and 1986, however in at the time of writing (1992) rockfalls “have only caused damage to property and public works, and inconvenience to residents”.

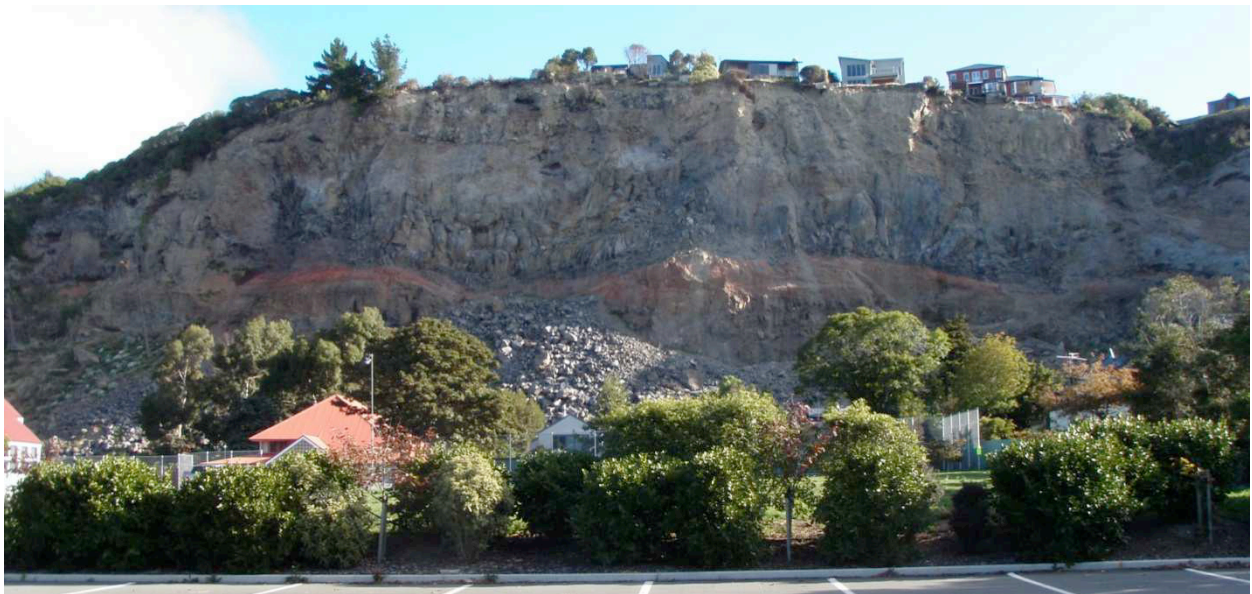
Figure 3.1: General view of the northeast facing cliff face at Redcliffs, photographed from Main Road on 4 April 2012. Note the orange tuff horizon exposed at mid-height, the channel-shaped structure in the centre-left, and the top of the large talus apron reaching the orange tuff near the centre of the photograph. Orange roof at left of centre is the now abandoned School Hall building.

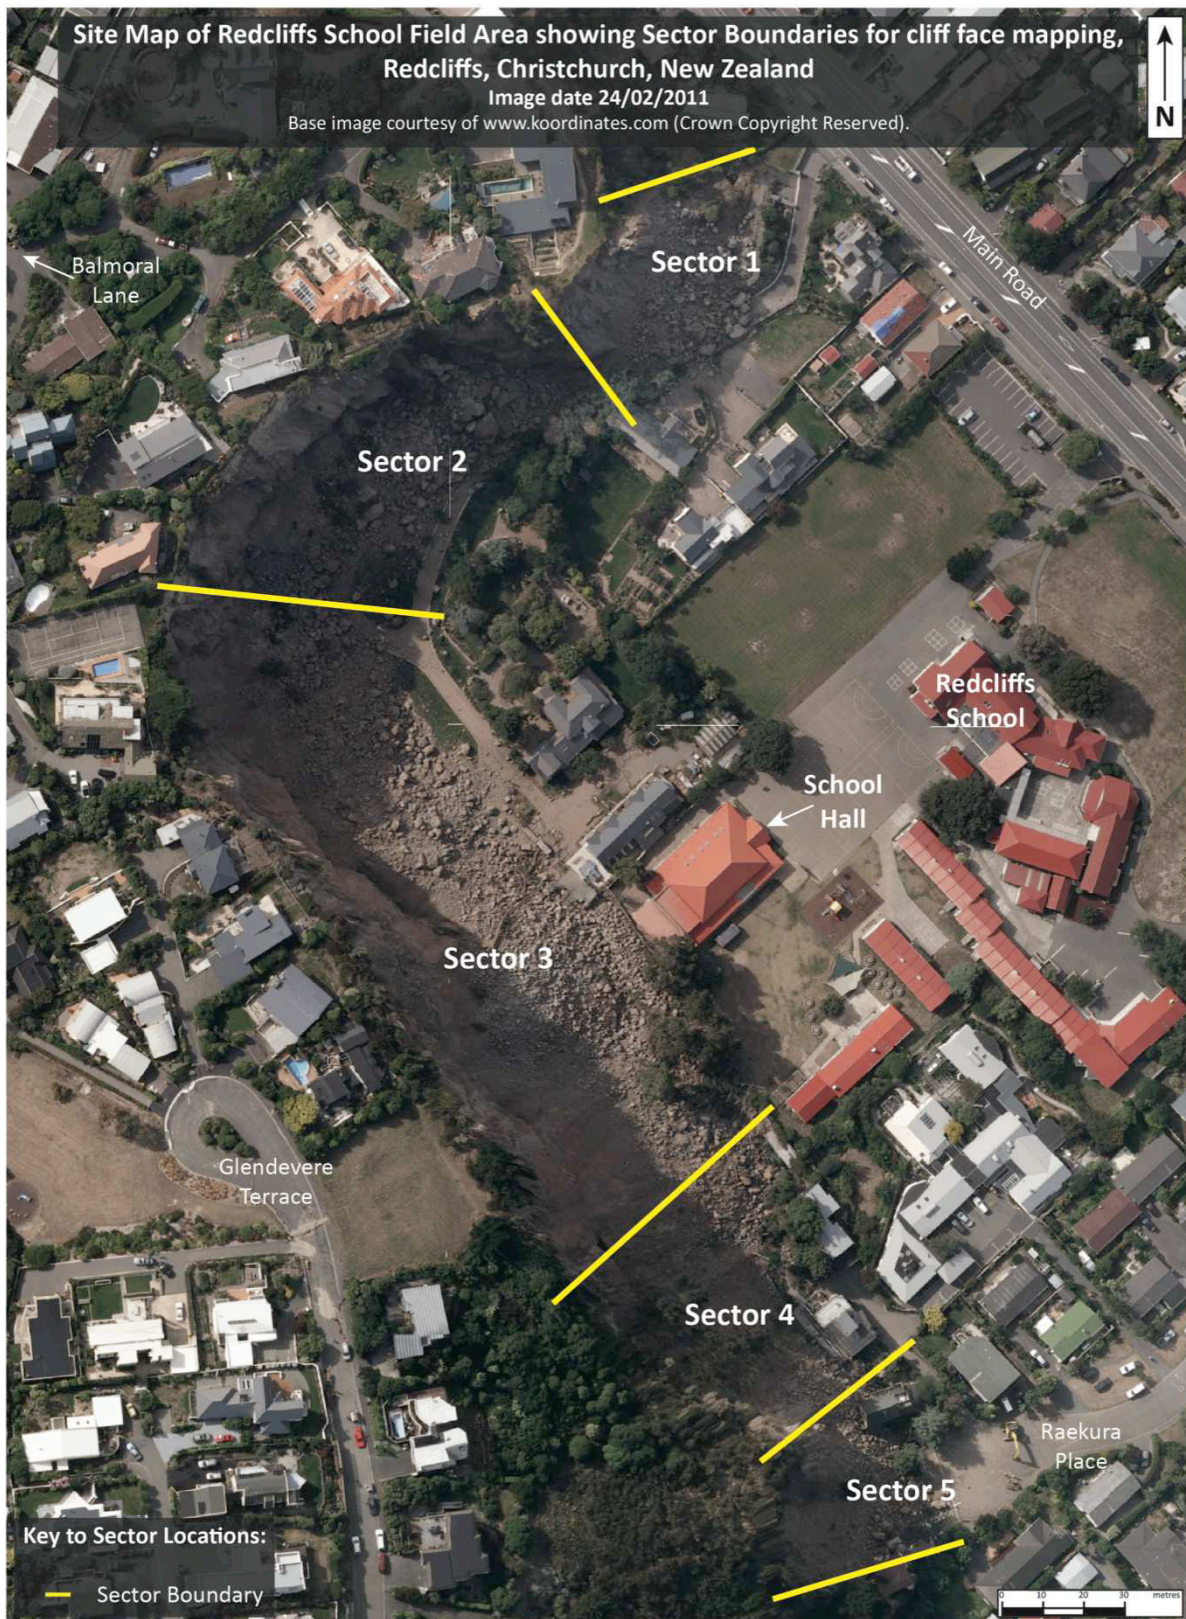
Figure 3.4: Sector location map.

The three bedrock units are discussed in the following sections (3.3-3.5). The Redcliffs field area was divided into five sectors for mapping purposes (Figure 3.4). These sectors were based on separating major changes in cliff face orientation (ie. cliff geometry), as well as the location of unobstructed photographs, with geological relationships playing a lesser role. Engineering geology face logs of these sectors are discussed in Chapter 4.

The basaltic ignimbrite unit directly overlies the orange tuff along the entire cliff exposure in Sectors 1, 2 and 3 (Figure 3.4). Engineering geology mapping of each of these three sectors is presented in Chapter 4. The basaltic ignimbrite dominates the cliff geology above the tuff horizon and is the main rockfall source material. As seen in Figure 3.1, the ignimbrite unit has a sharp, undulating basal contact with the orange tuff. Above this, the ignimbrite unit consists of a blue-grey, jointed basal section, grading into a whitish-grey, massive section above. In

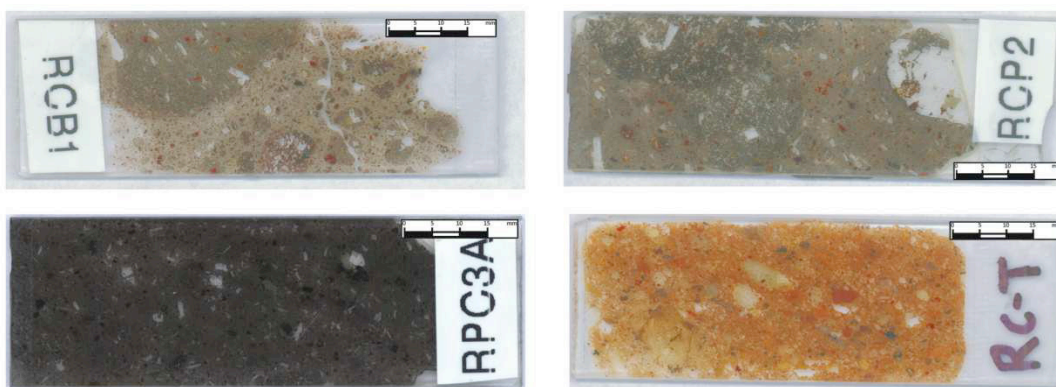
Figure 3.8: Example of thin section slides from Redcliffs. RCB1: Brecciated basaltic ignimbrite; RCP2 & RPC3A: welded basaltic ignimbrite; RC-T: Orange tuff. Scale bar on each slide is ~15mm long.

Samples of the orange tuff and the brecciated ignimbrite, and two samples of the welded ignimbrite were collected and thin sections produced (Figure 3.8). Analysis is presented at the scale of the slides as shown in Figure 3.8, rather than as viewed down a microscope. This is because alteration textures were more clearly visible at this scale, and therefore the variation between rock units is more obvious. Brief descriptions of composition and textures visible in thin section slides are presented in this section

Of particular interest was the comparison between the brecciated and welded ignimbrites, as the increase in degree of welding was clearly evident in the thin section textures. The transition along the welding continuum was of interest to the modelling of rockfall at this site, because rock strength plays an important role in determining how a rock will behave during movement downslope.

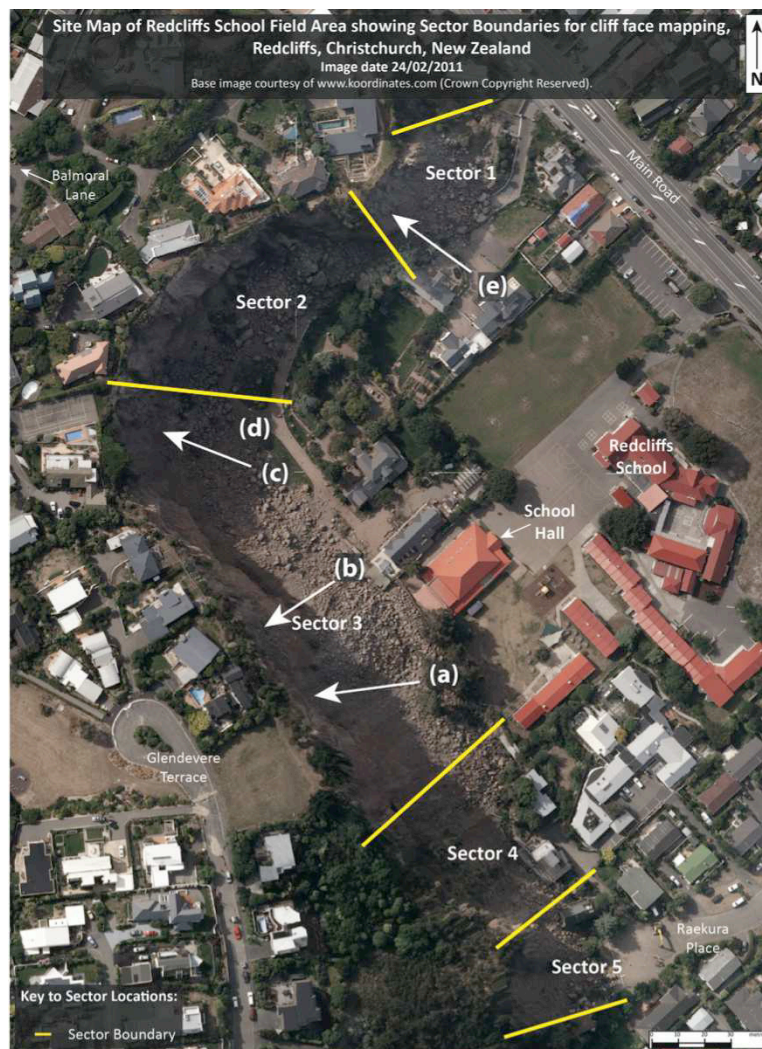
Figure 3.10: Approximate location of observed ignimbrite identification features. (a) Irregularly spaced jointing; (b) welded ignimbrite bands within brecciated ignimbrite; (c) sharp basal contact; (d) possible example of lithic lag in boulder at the base of the talus slope; (e) crude vertical cooling joints in brecciated ignimbrite (Sector 1).

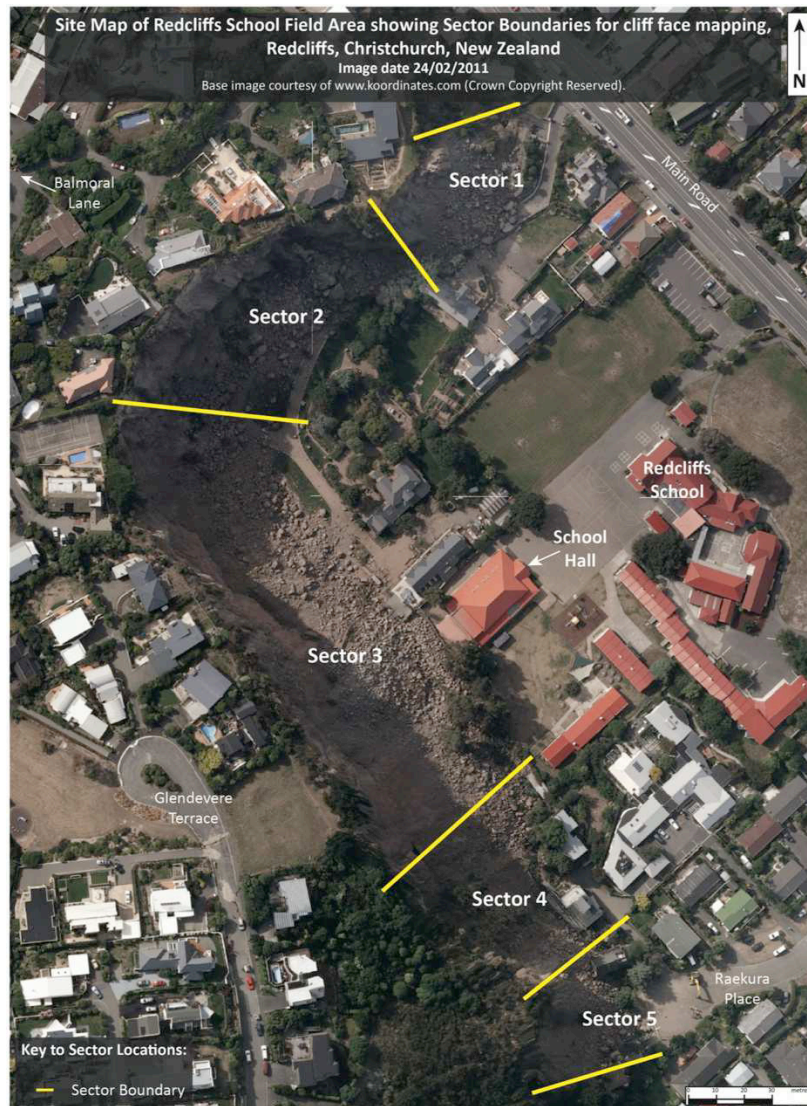
Figure 4.1: Sector boundaries as used for mapping.

As discussed in Section 3.3, the Redcliffs field area was divided into five sectors for mapping purposes (reproduced in Figure 4.1 as for Figure 3.4). Engineering geology face maps of Sectors 1-3 are presented in Figure 4.2, Figure 4.4 and Figure 4.3 respectively.

The focus area for mapping and subsequent rockfall modelling was constrained to Sectors 1-3 (Figure 4.1). Sectors 4-5 were included in initial field reconnaissance mapping, but due to different and more complex geology as well as time constraints, these two Sectors were excluded from future detailed analysis and RocFall™ modelling. Sector 4 was largely unaffected by cliff collapse, with only localised rockfall in places. Because of the lack of disturbance, the cliff face and lower slope area was vegetated, obscuring view in some areas, and the geology appeared to be becoming more complex towards the south-east. Sector 5 was more complex again, with units at this site lying stratigraphically above the main Redcliffs succession.

Sector 1 is the most northerly sector within the field area (Figure 4.1). As shown in the engineering geology face log (Figure 4.2), the area consists of a thick basal unit of orange tuff (up to 8m exposed thickness), overlain by up to 7m of variably welded basaltic ignimbrite,

Sector 3 covered the largest segment of the cliff in the field area (Figure 4.1), and was dominated by extensive talus slopes, with thick ignimbrite deposits and variable jointing in the welded unit above the orange tuff (Figure 4.5). The lowest units visible were the probable lava flows. Although not accessed, these were well exposed in places, but samples from these units were not able to be identified in the talus deposits due to the chaotic sorting. Up to three individual lava flows were identified,

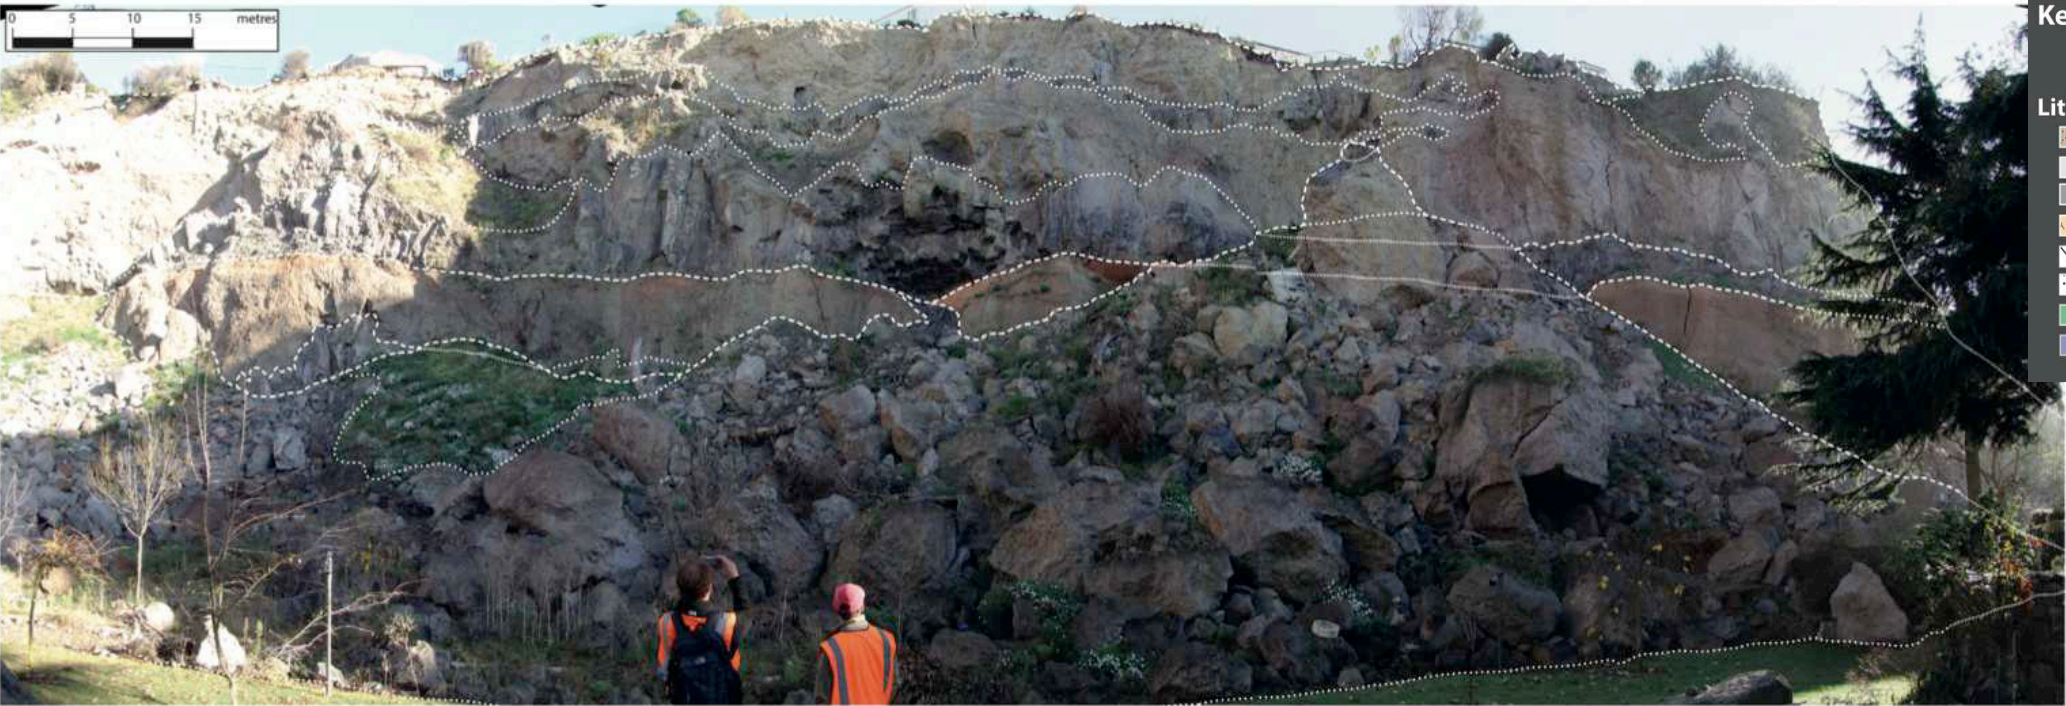
Sector 2 Face Log, Redcliffs

Image date April 2012

Key to Map 2 (Sector 2):
Engineering Geology Face Log

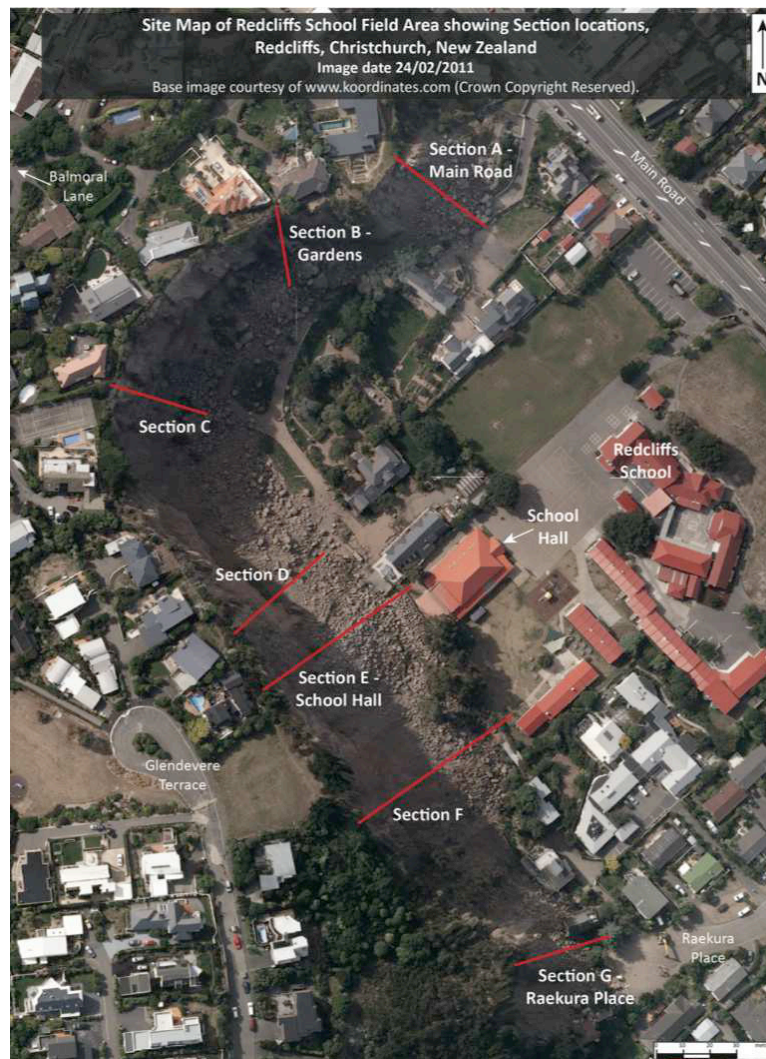
Figure 5.1: Section location map, Redcliffs.

The location of the School Hall Section (Section E) was chosen as it provides a central study site on the highest part of the cliff section at Redcliffs, where large-scale failure has occurred during both 22 February 2011 and 13 June 2011 earthquake events (Figure 5.1). It is also an area where high-resolution slope survey data has been obtained by GNS Science along the full length of the slope. In addition, it is an area that affords good access for field calibration within the limits of safety that are required. Map coordinates at the base of the section are - 43.55972°, 172.73298° (Cubrinovski et al. 2011), and a detailed plan map is shown in Figure 5.2.

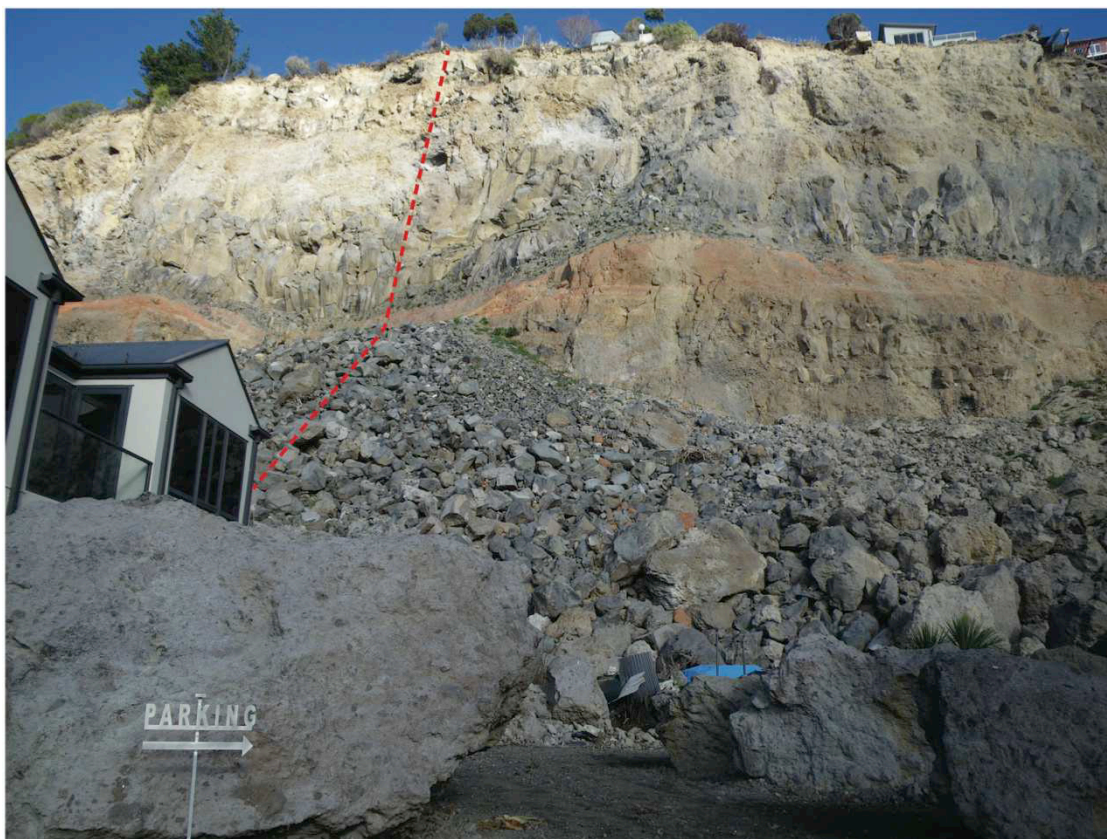
Figure 5.4: Photo looking southwest towards the main section of the cliff showing gravity sorting of talus slope, School Hall Section (Section E), Recliffs. Approximate location of Section E shown by dashed red line. Note relatively small blocks near the top of the talus slope in contrast to the large blocks at the base. Large block in left fore-ground is approximately 2m high and ~4m wide (~25m³; left-hand end not shown). Blue object at the base of the slope (centre-right) is the buried car indicated in Figure 4.2. Large, angular blocks in the immediate foreground were released from the face during the 13 June cliff collapse event. Photo credit: Sam Hampton, June 2012.

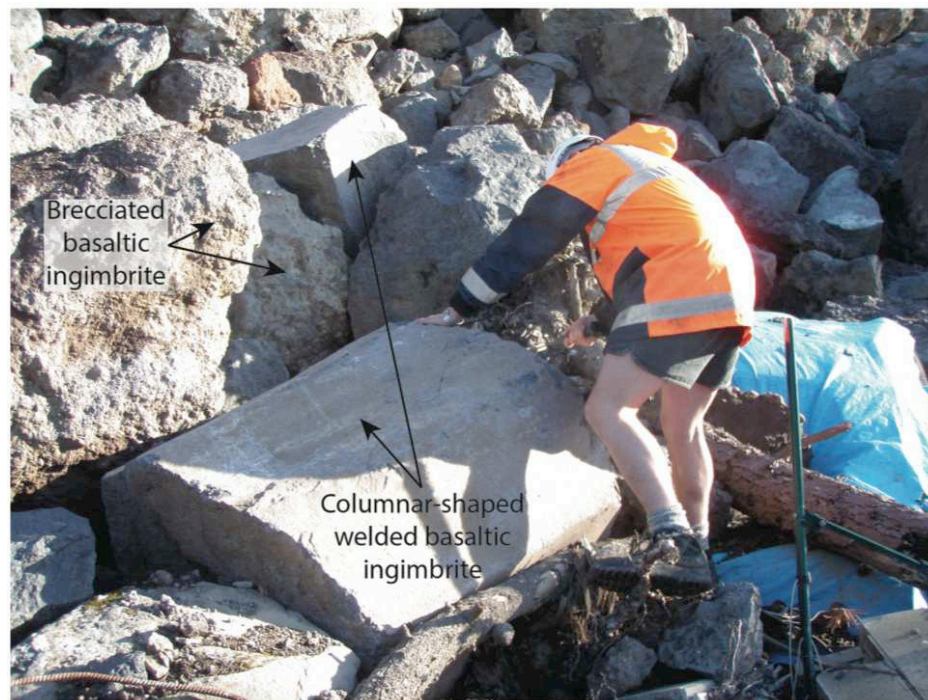
Figure 5.8: Example of columnar-shaped welded basaltic ignimbrite blocks from Area 3, and brecciated basaltic ignimbrite blocks from Area 3, and brecciated basaltic ignimbrite example from Area 1 or 2. Block size up to maximum of 5t or 5,000kg.

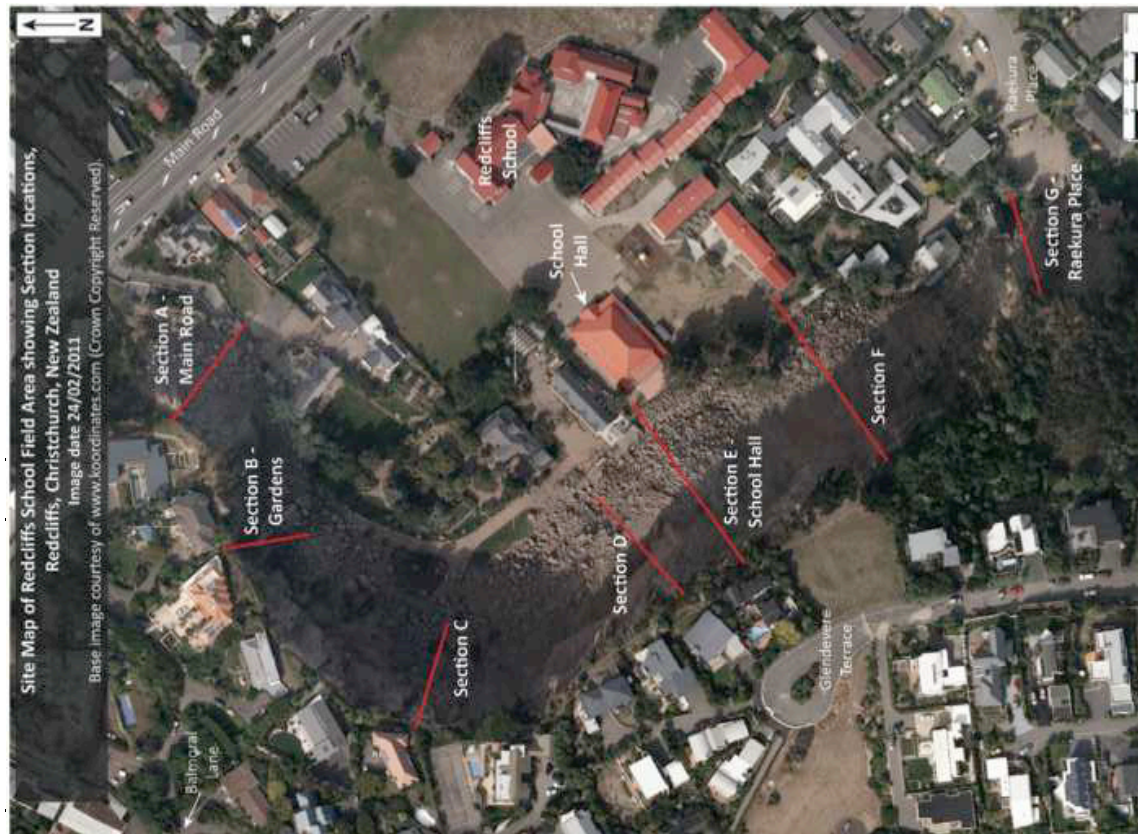
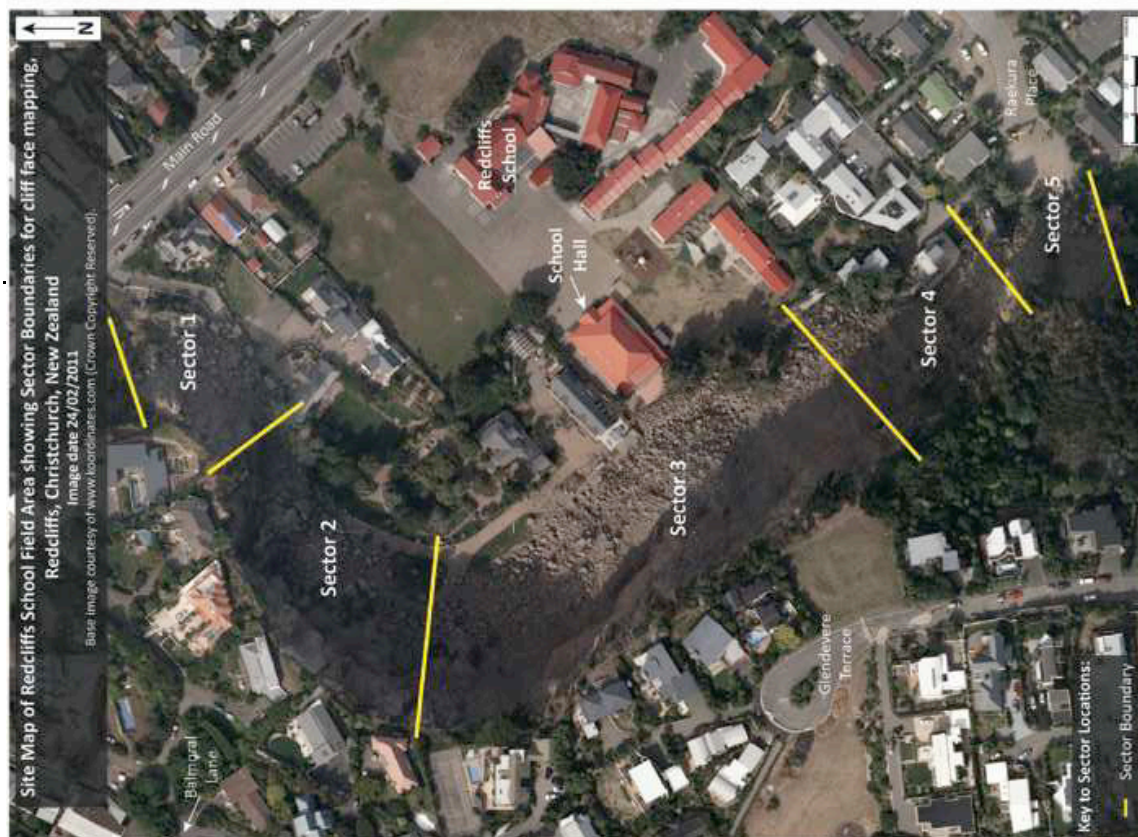
Figure 6.1: Sector boundary (left) and modelling section line (right) location maps, Redcliffs.

The section lines selected for rockfall modelling at Redcliffs are displayed in Figure 6.1. Sections A – D are discussed in this chapter, and Section E is discussed in detail in Chapter 5. As discussed in Section 4.3.2, Sectors 4 and 5 (including Section Lines F and G) were included in initial field reconnaissance mapping, however they have been excluded from further detailed analysis and RocFall™ modelling.

Section C is located in the northwest corner of the cliff face, near the boundary between Sectors 2 and 3 (Figure 6.1). In the general path of this section is a residential dwelling, located approximately 30m from the toe of the observed rockfall runout.
